**Flood Control Project Maintenance  
Levee Inspections**  
**LMA District Cover Sheet**  
**Spring 2010 Levee Inspection Results**

**Reclamation District No. 1001 Nicolaus**

**Levee Inspection Report By Mile - Spring 2010**

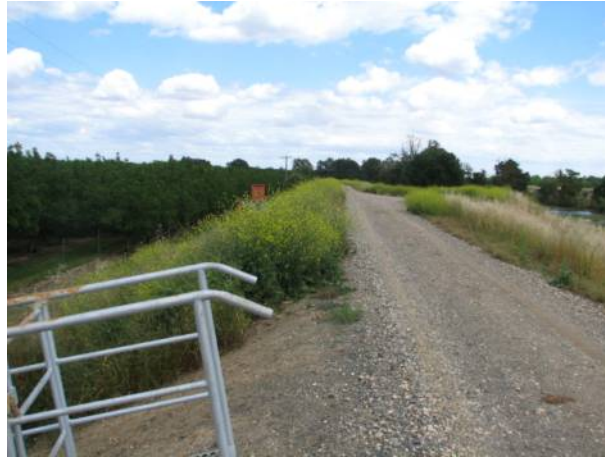
Levee Mile Report Line	1
Start Levee Mile	0.48
End Levee Mile	4.15
Location	Land Side
Category	Earthen Levee
Item	Vegetation

Land side vegetation levee mile 3.85.

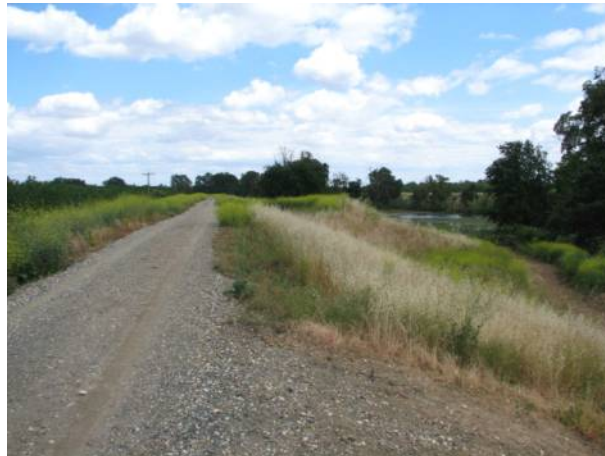
Levee Mile Report Line	2
Start Levee Mile	0.48
End Levee Mile	4.15
Location	Water Side
Category	Earthen Levee
Item	Vegetation

Water side vegetation levee mile 3.85.

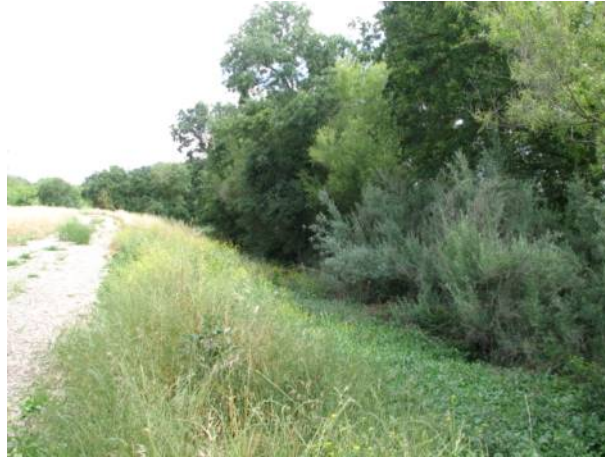
Levee Mile Report Line	1
Start Levee Mile	0.00
End Levee Mile	3.65
Location	Water Side
Category	Earthen Levee
Item	Vegetation
Water side vegetation levee mile 0.00.	
cathom_s_20100603_094.jpg

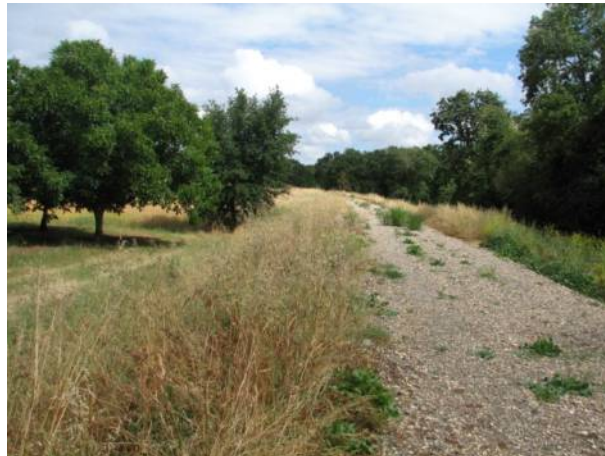
Levee Mile Report Line	2
Start Levee Mile	0.00
End Levee Mile	3.65
Location	Land Side
Category	Earthen Levee
Item	Vegetation
Land side vegetation levee mile 0.00.	
cathom_s_20100603_095.jpg

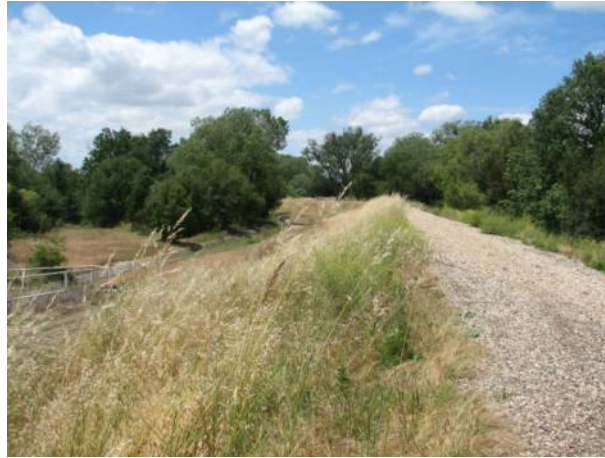
Levee Mile Report Line	1
Start Levee Mile	0.00
End Levee Mile	12.60
Location	Land Side
Category	Earthen Levee
Item	Vegetation

Land side vegetation levee mile 0.00.

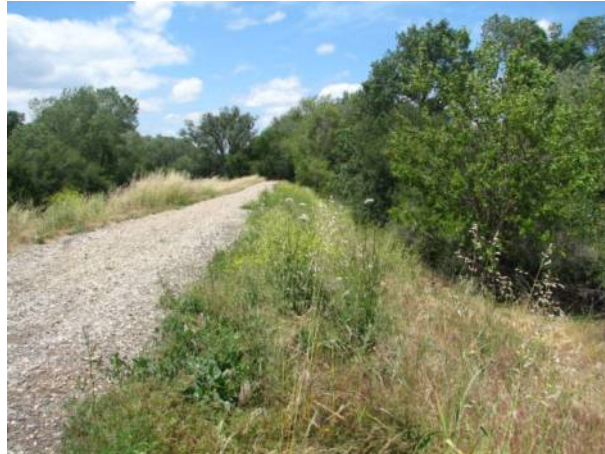
Levee Mile Report Line	2
Start Levee Mile	0.00
End Levee Mile	12.60
Location	Water Side
Category	Earthen Levee
Item	Vegetation

Water side vegetation levee mile 0.00.

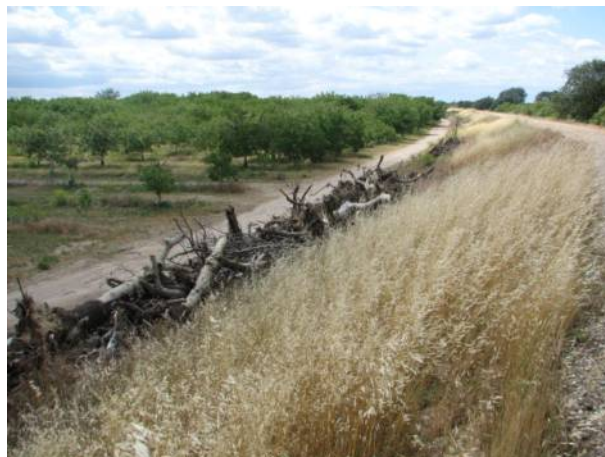
Levee Mile Report Line	7
Start Levee Mile	4.30
End Levee Mile	4.61
Location	Land Side
Category	Earthen Levee
Item	Encroachments

Prunings on the levee slope levee mile 4.35.

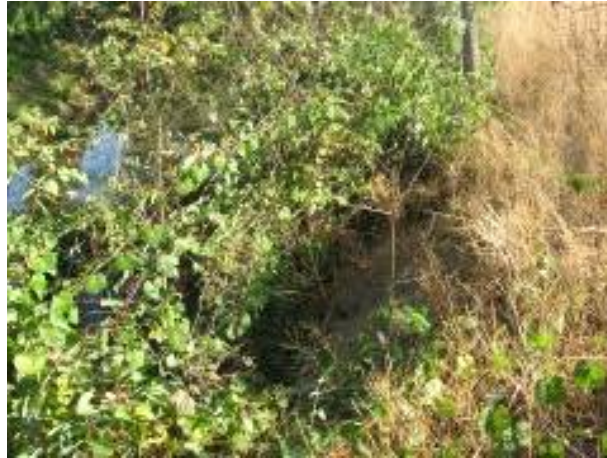
Levee Mile Report Line	15
Start Levee Mile	12.16
End Levee Mile	12.22
Location	Water Side
Category	Supplemental
Item	USACE Erosion Survey
2009: 15 ft berm, 1:1 slope, tree hazards, holes, slumping, and seepage, clays and silts, 2.84 ft/s [2009 SiteID:BER_0-8_L]	
USACE2009_BER_0-8_L_2009_09_24-D9P27_small.JPG

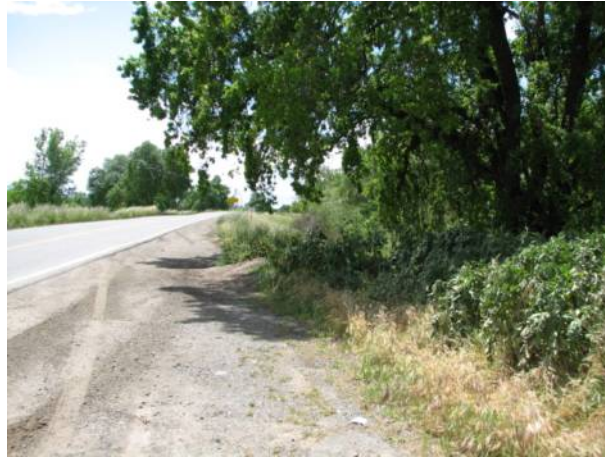
Levee Mile Report Line	1
Start Levee Mile	0.00
End Levee Mile	13.33
Location	Water Side
Category	Earthen Levee
Item	Vegetation

Water side vegetation levee mile 5.23.

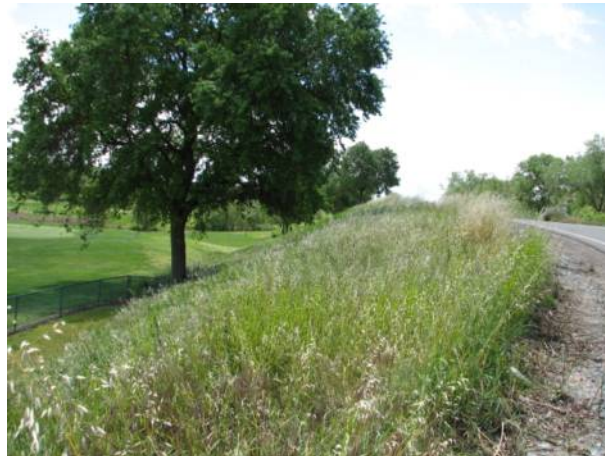
Levee Mile Report Line	2
Start Levee Mile	0.00
End Levee Mile	13.33
Location	Land Side
Category	Earthen Levee
Item	Vegetation

Land side vegetation levee mile 5.23.

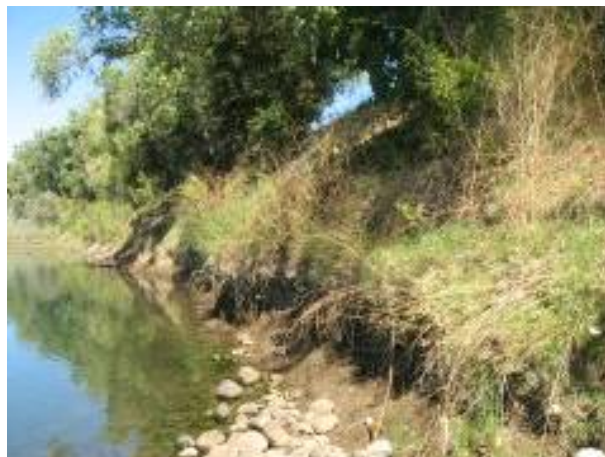
Levee Mile Report Line	4
Start Levee Mile	5.42
End Levee Mile	5.51
Location	Water Side
Category	Supplemental
Item	USACE Erosion Survey

2009: 5 ft berm, 2.5:1 slope, tree hazards, seepage, and slumping, sands and silts, 9.97 ft/s  
[2009 SiteID:FHR\_7-0\_L]

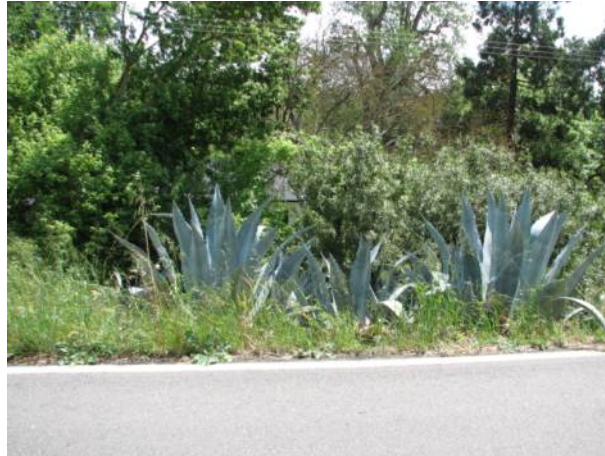
Levee Mile Report Line	5
Start Levee Mile	6.48
End Levee Mile	6.48
Location	Land Side
Category	Earthen Levee
Item	Encroachments
Landscaping on the land side shoulder and slope levee mile 6.48.	
cathom_s_20100603_086.jpg

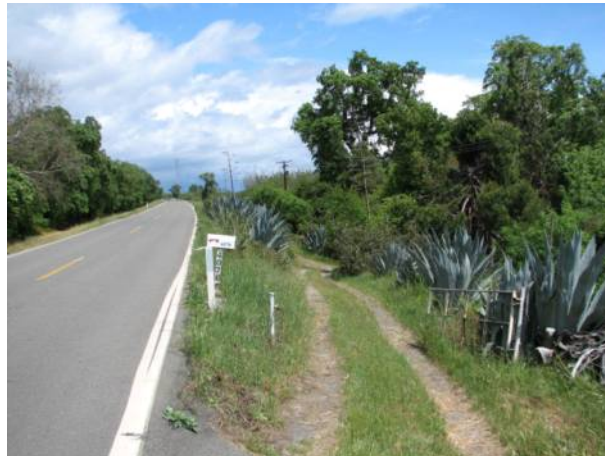
Levee Mile Report Line	5
Start Levee Mile	6.48
End Levee Mile	6.48
Location	Land Side
Category	Earthen Levee
Item	Encroachments
Landscaping levee mile 6.48.	
cathom_s_20100603_087.jpg

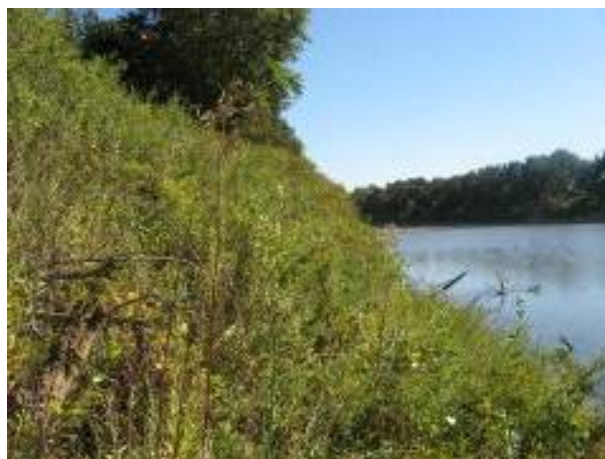
Levee Mile Report Line	10
Start Levee Mile	11.26
End Levee Mile	11.45
Location	Water Side
Category	Supplemental
Item	USACE Erosion Survey
2009: 15 ft berm, 1:1 slope, tree hazards and seepage, sands and silts, 5.46 ft/s [2009 SiteID:FHR_1-0_L]	
USACE2009_FHR_1-0_L_2009_09_21-D6P30_small.JPG

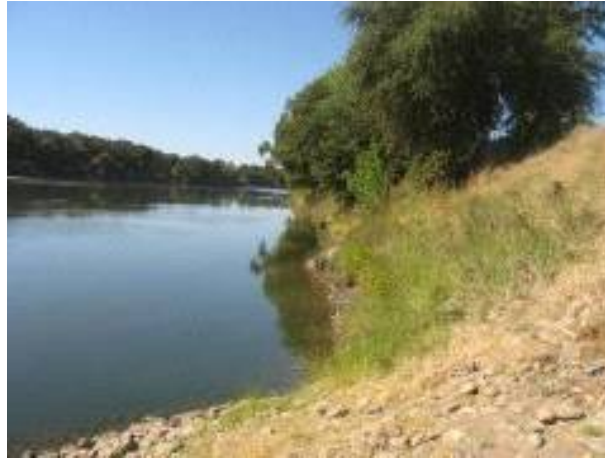
Levee Mile Report Line	12
Start Levee Mile	11.80
End Levee Mile	11.83
Location	Water Side
Category	Supplemental
Item	USACE Erosion Survey
2009: 15 ft berm, 2.5:1 slope, tree hazards, seepage, and slumping, sands and cobbles, 4.8 ft/s [2009 SiteID:FHR_0-6_L]	
USACE2009_FHR_0-6_L_2009_09_21-D6P31_small.JPG

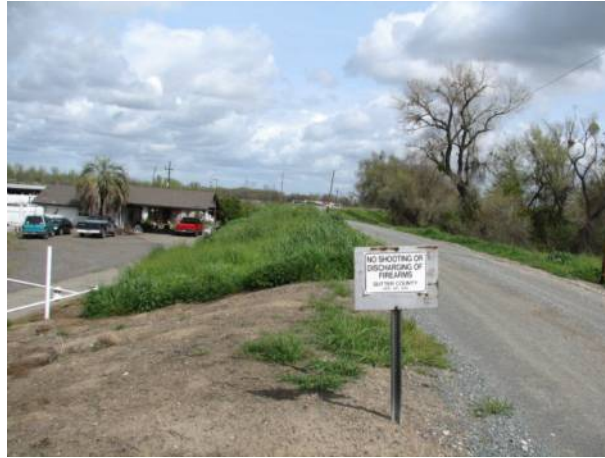
The land side slope levee mile 0.00

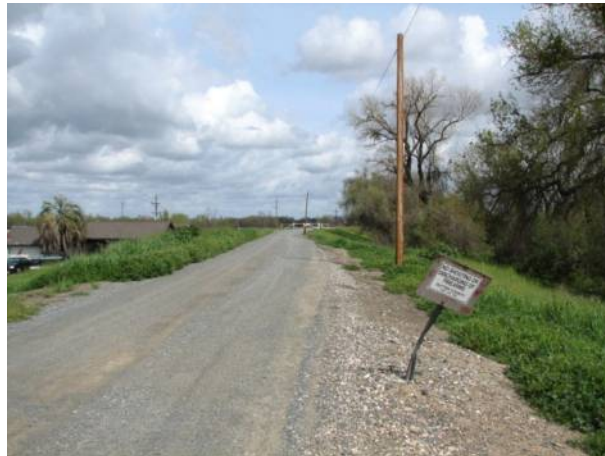
Levee Mile Report Line	2
Start Levee Mile	0.00
End Levee Mile	0.75
Location	Water Side
Category	Earthen Levee
Item	Encroachments

Poles on the water side shoulder levee mile 0.00 - 0.75

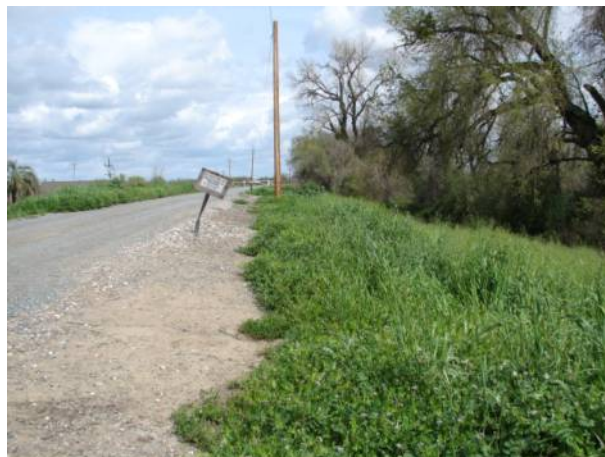
Levee Mile Report Line	3
Start Levee Mile	0.12
End Levee Mile	5.43
Location	Water Side
Category	Earthen Levee
Item	Vegetation

Water side levee slope levee mile 0.00

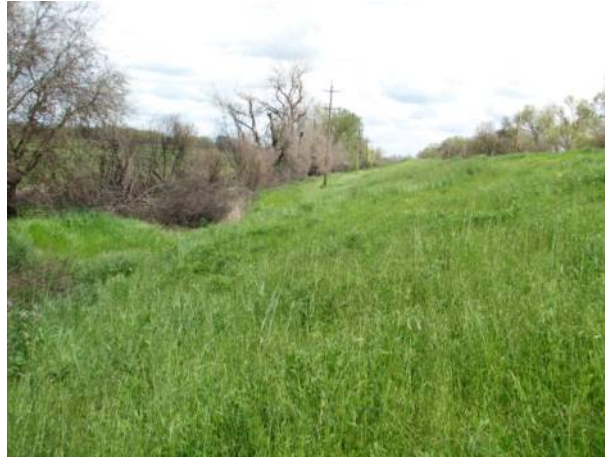
Poles at the land side toe levee mile 0.19 - 0.86.

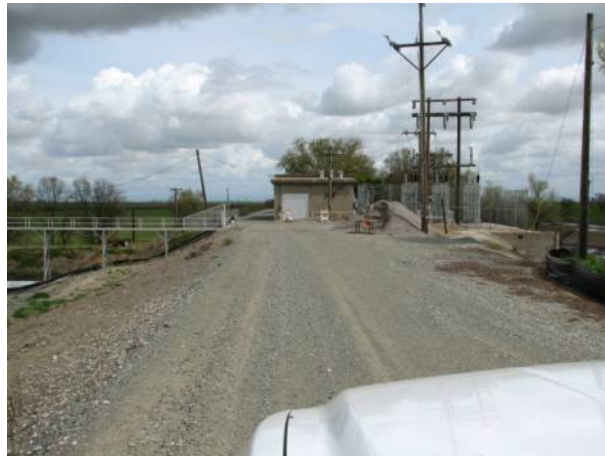
Levee Mile Report Line	5
Start Levee Mile	0.83
End Levee Mile	0.83
Location	Water Side
Category	Earthen Levee
Item	Encroachments

Pump house on the water side levee mile 0.83.

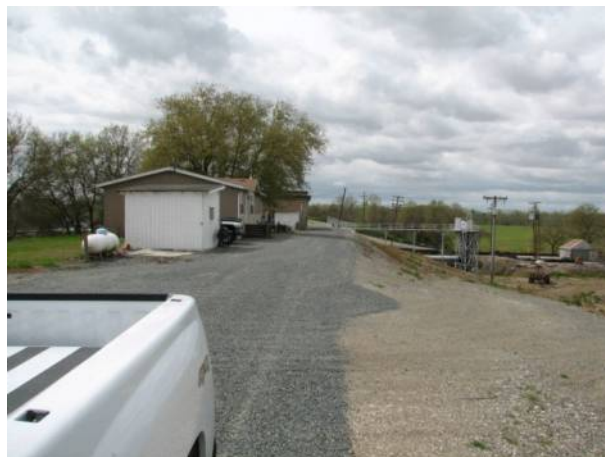
Levee Mile Report Line	5
Start Levee Mile	0.83
End Levee Mile	0.83
Location	Water Side
Category	Earthen Levee
Item	Encroachments

Pump house and Caretakers home levee mile 0.83

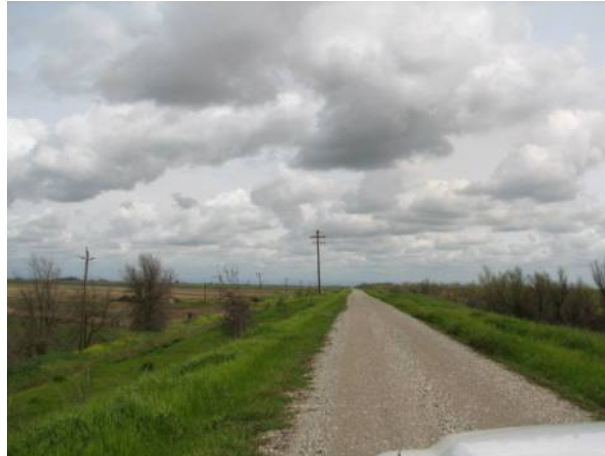
Levee Mile Report Line	6
Start Levee Mile	1.15
End Levee Mile	1.15
Location	Land Side
Category	Earthen Levee
Item	Encroachments
Pole on land side shoulder levee mile 1.15.	
cathom_s_20100421_010.jpg

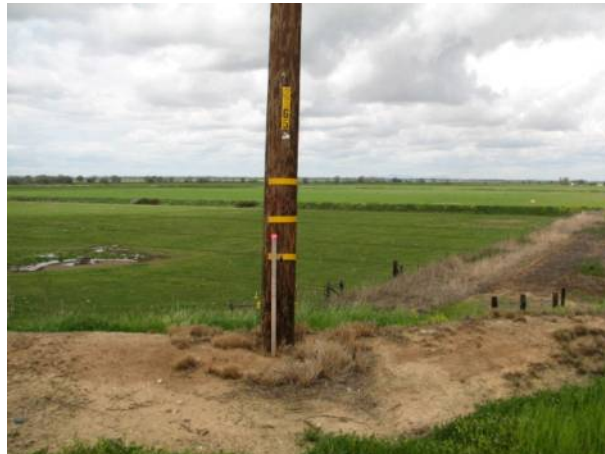
Levee Mile Report Line	6
Start Levee Mile	1.15
End Levee Mile	1.15
Location	Land Side
Category	Earthen Levee
Item	Encroachments
Pole on land side shoulder.	
cathom_s_20100421_011.jpg

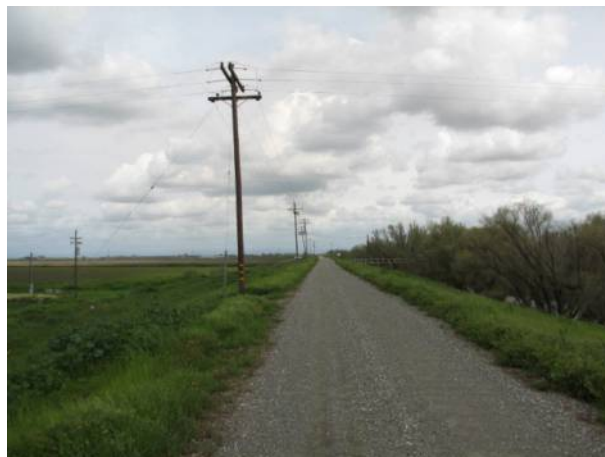
Levee Mile Report Line	7
Start Levee Mile	3.59
End Levee Mile	3.85
Location	Land Side
Category	Earthen Levee
Item	Encroachments
Poles on the land side shoulder levee mile 3.59 - 3.85.	
cathom_s_20100421_012.jpg

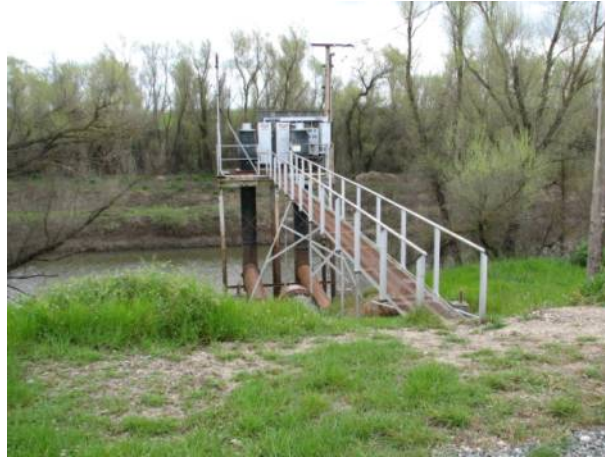
Pump water side levee mile 3.69.

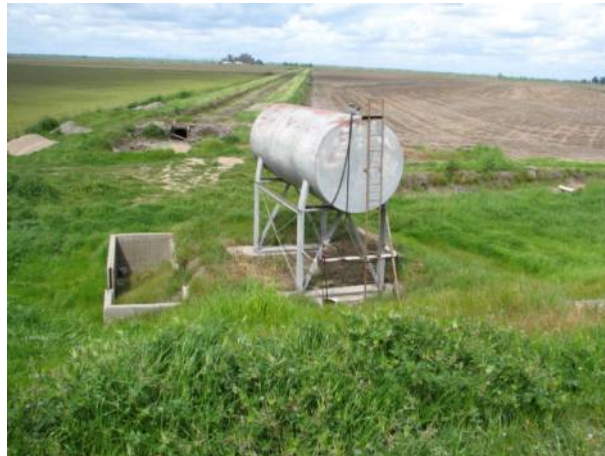
Levee Mile Report Line	11
Start Levee Mile	3.85
End Levee Mile	3.85
Location	Land Side
Category	Earthen Levee
Item	Encroachments

Storage tank on land side slope levee mile 3.85.

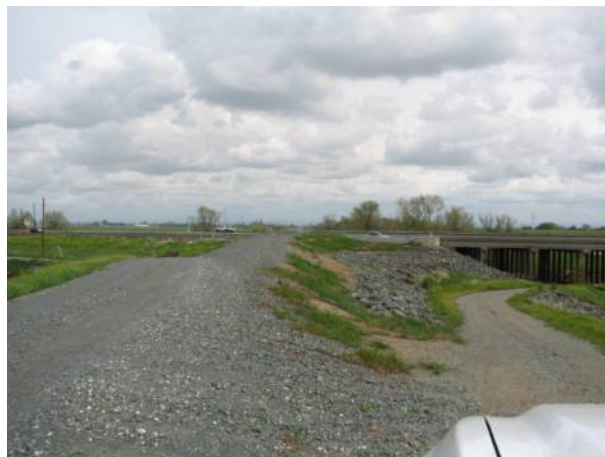
Levee Mile Report Line	12
Start Levee Mile	4.44
End Levee Mile	4.44
Location	Crown
Category	Earthen Levee
Item	Encroachments

Levee stops at hwy 70 and starts again on the other side of hwy 70.

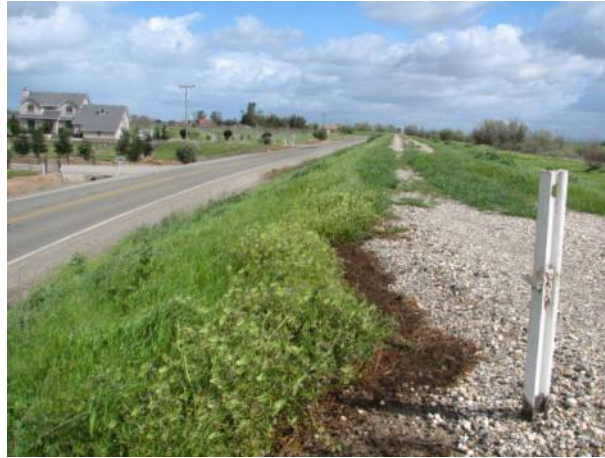
The land side levee slope at L/M 0.44.

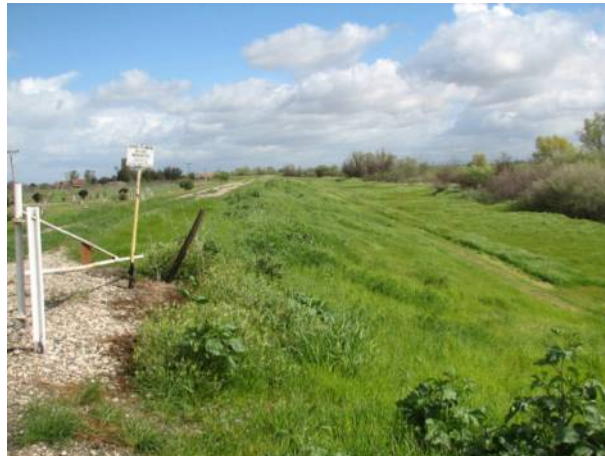
Levee Mile Report Line	2
Start Levee Mile	0.00
End Levee Mile	1.06
Location	Water Side
Category	Earthen Levee
Item	Vegetation

The water side levee slope at L/M 0.44.

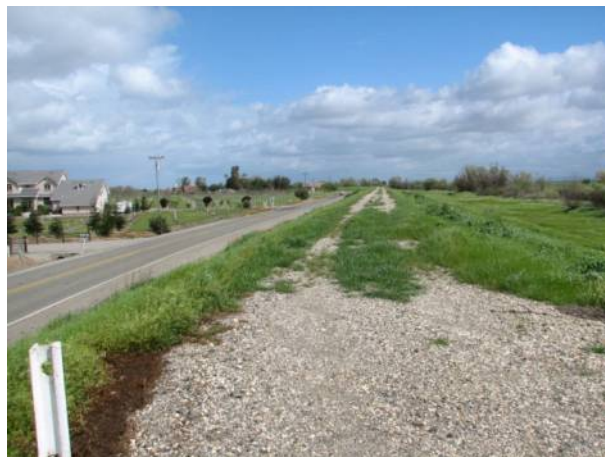
Levee Mile Report Line	3
Start Levee Mile	0.47
End Levee Mile	1.23
Location	Crown
Category	Earthen Levee
Item	Vegetation

The crown roadway at L/M 0.44.

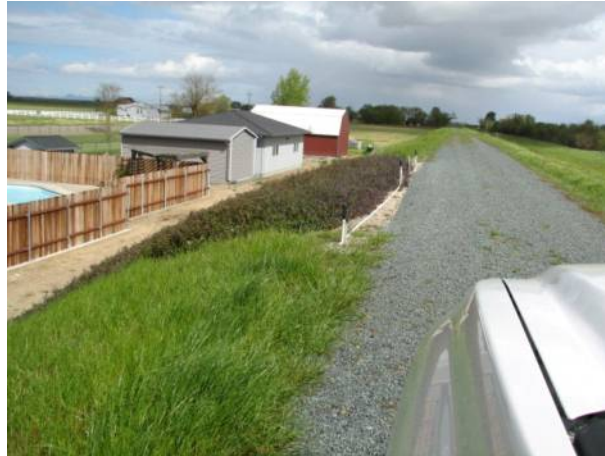
Levee Mile Report Line	5
Start Levee Mile	1.06
End Levee Mile	1.06
Location	Land Side
Category	Earthen Levee
Item	Encroachments
Landscaping on the land side slope L/M 1.06.	
cathom_s_20100513_019.jpg

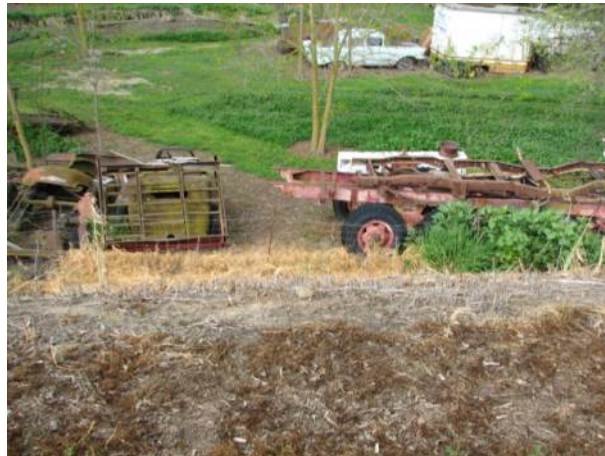
Levee Mile Report Line	6
Start Levee Mile	1.37
End Levee Mile	1.37
Location	Land Side
Category	Earthen Levee
Item	Encroachments
Equipment at the land side toe L/M 1.37.	
cathom_s_20100513_020.jpg

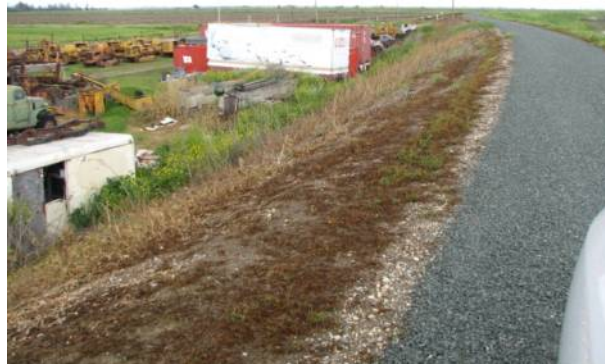
Levee Mile Report Line	7
Start Levee Mile	1.45
End Levee Mile	1.45
Location	Land Side
Category	Earthen Levee
Item	Encroachments
Equipment at the land side toe L/M 1.45.	
cathom_s_20100513_021.jpg
